NATIONAL LOTTERIES COMMISSION (NLC)

MUKONDENI SPORTS FACILITY - LIMPOPO

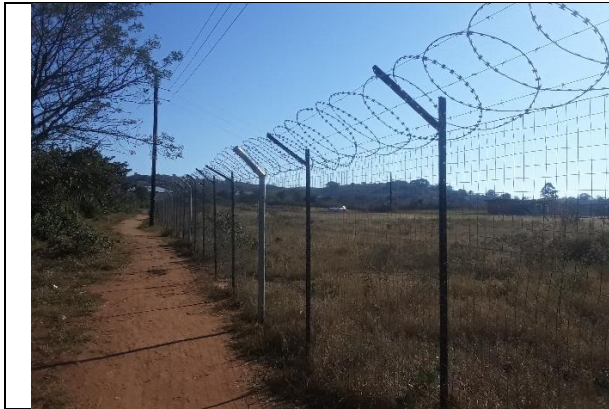
Fig.4.1: Fencing intact and in satisfactory condition

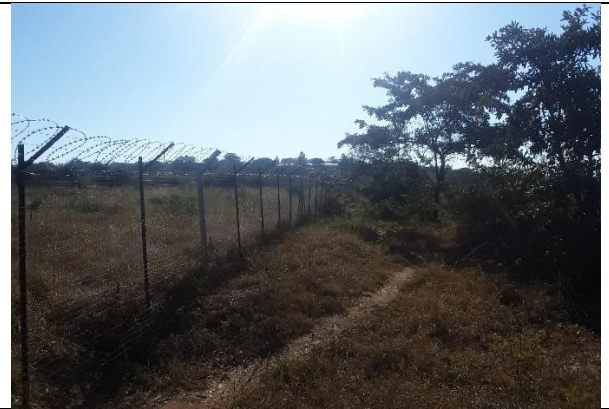
Fig.4.2: Fence is intact and in satisfactory condition

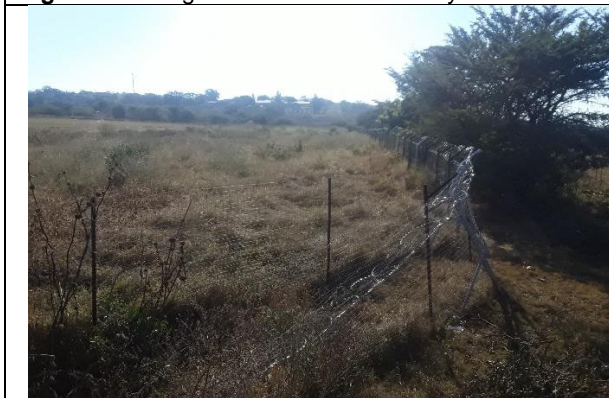
Fig.4.3: Fence on the southern border has collapsed/duplicated.

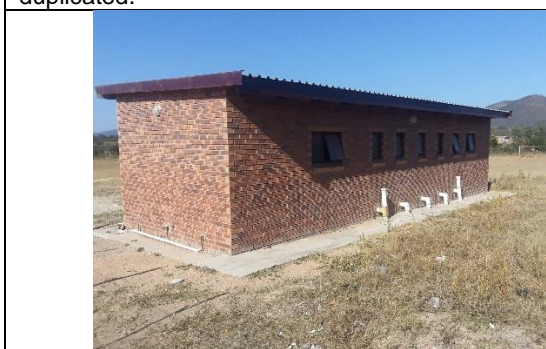
Fig.4.5: Change Rooms in good condition

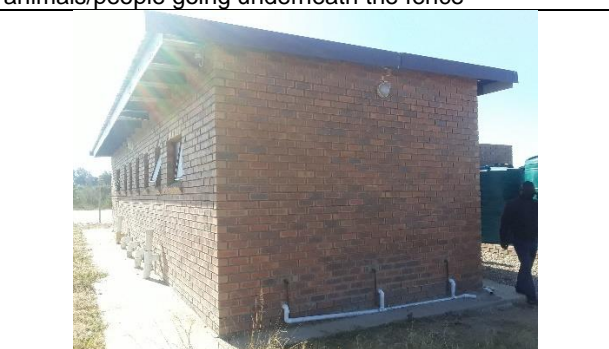
Fig. 4.6: Change Rooms in good condition

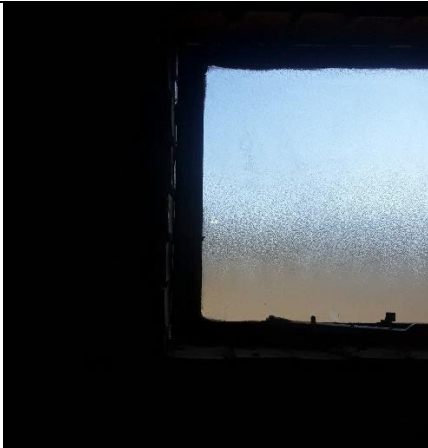
Fig.4.7: Gap between the brick and window frames need to be closed by grout

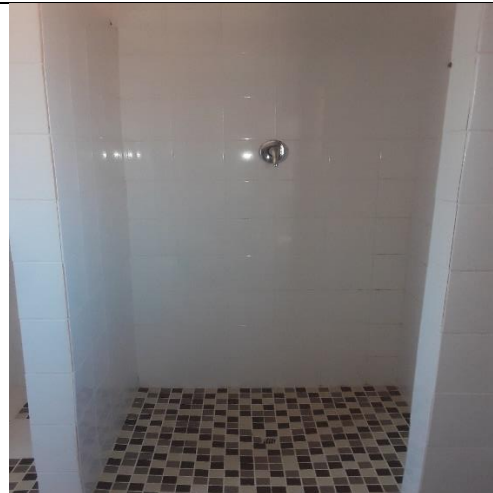
Fig.4.10: Shower intact and in satisfactory condition

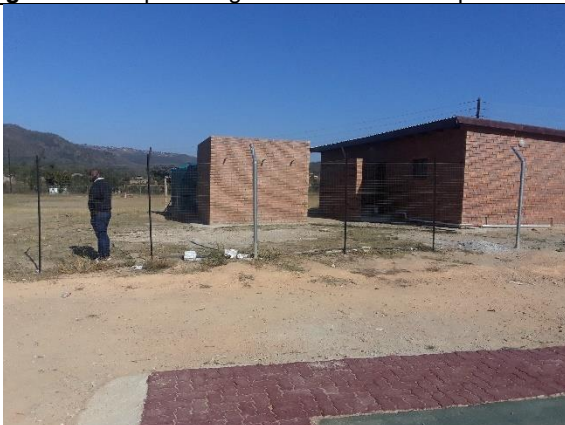
Fig.4.11: Storage Building generally in satisfactory condition.

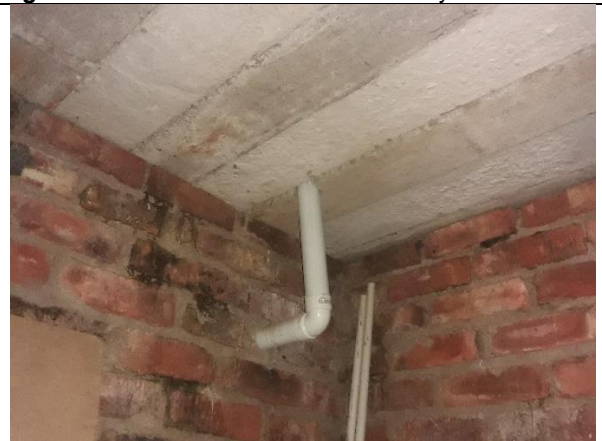
Fig.4.12: Storage Building Roof intact and in satisfactory condition

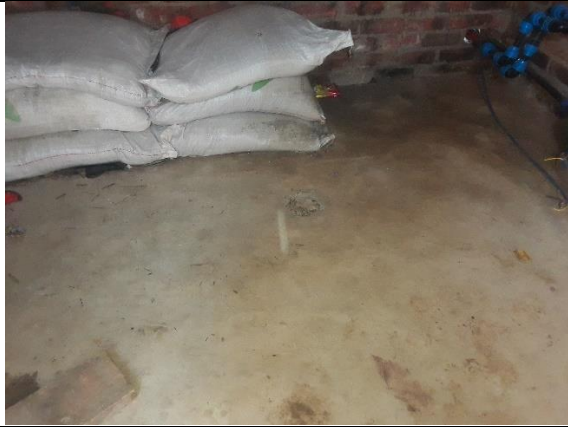
Fig.4.13: Storage Building floor minor damages to be fixed

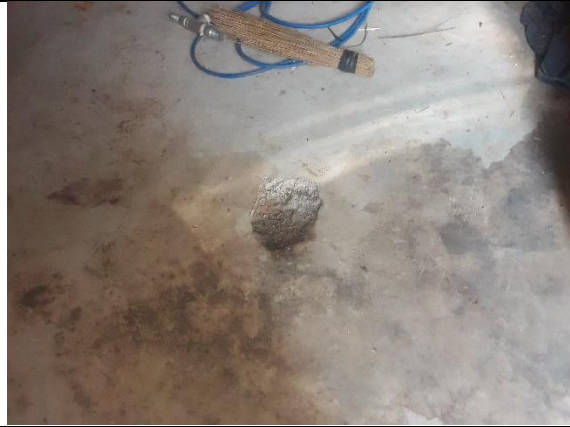
Fig.4.14: Storage Building floor minor damages to be fixed

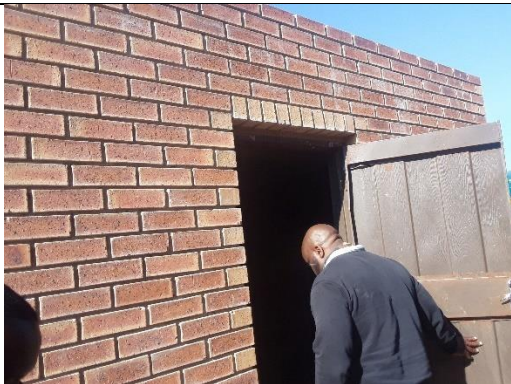
Fig.4.15: Storage Building steel door to be replaced with a louvred door to allow ventilation.

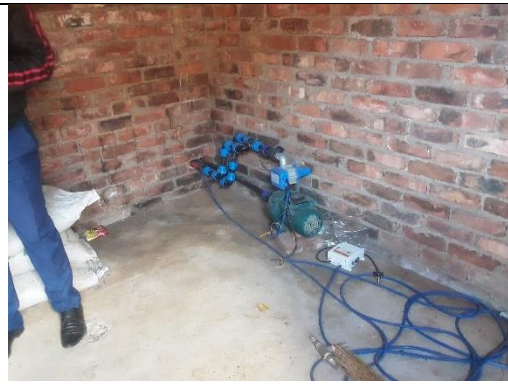
Fig.4.16: Storage Building with borehole pump

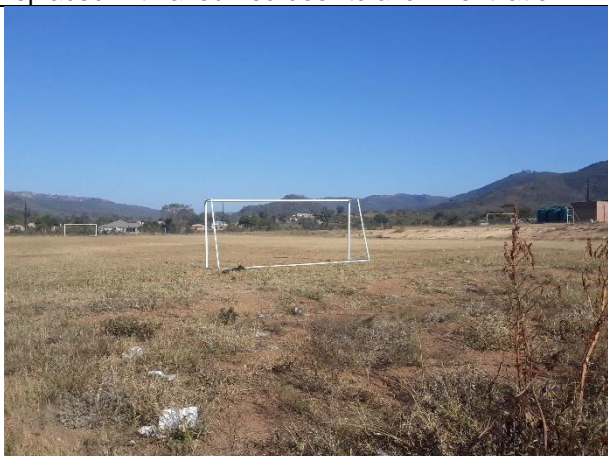
Fig.4.17: Soccer Field in satisfactory condition

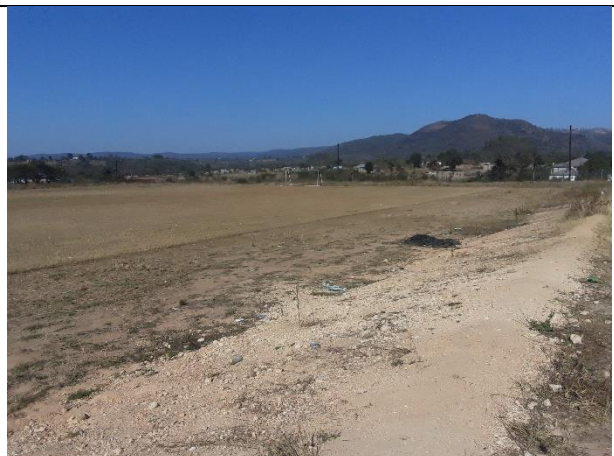
Fig.4.18: Soccer Field in satisfactory condition

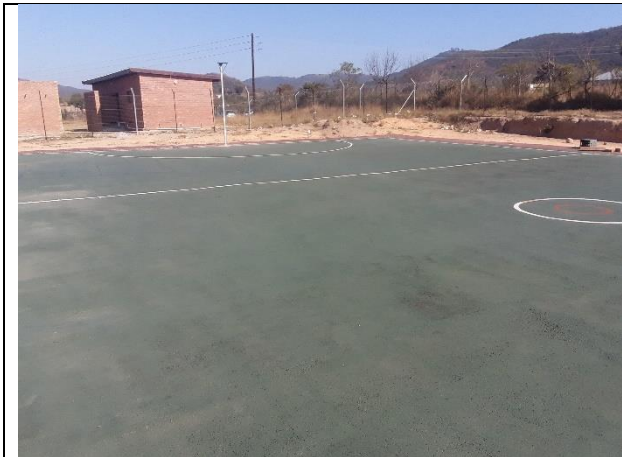
Fig.4.19: Netball Court in a satisfactory condition

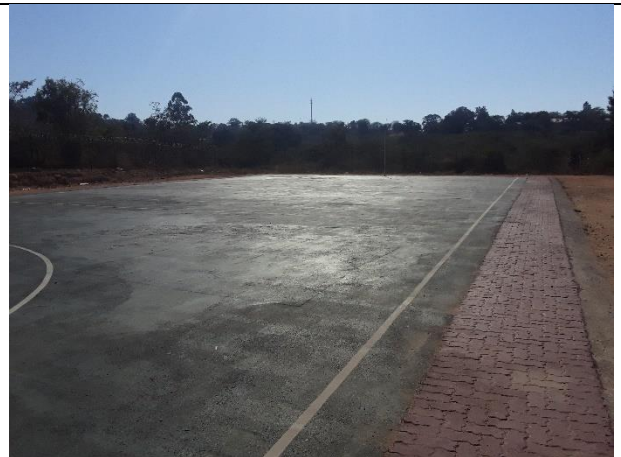
Fig.4.20: Netball Court in a satisfactory condition

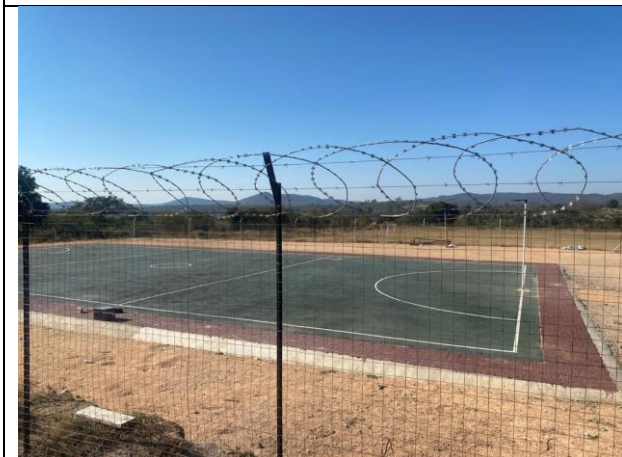
Fig.4.21: Netball Court in a satisfactory condition

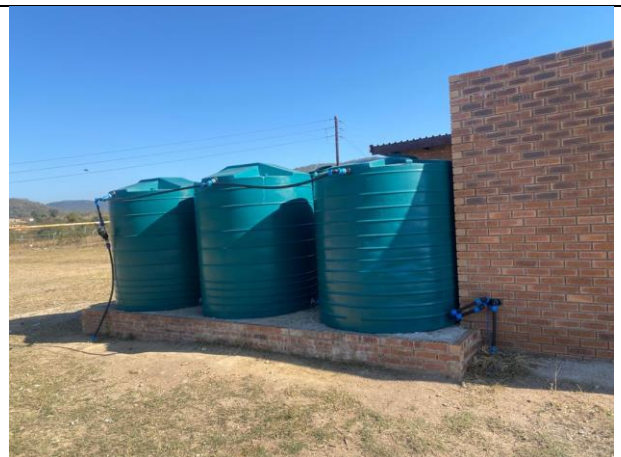
Fig.4.22: Water tanks in satisfactory condition

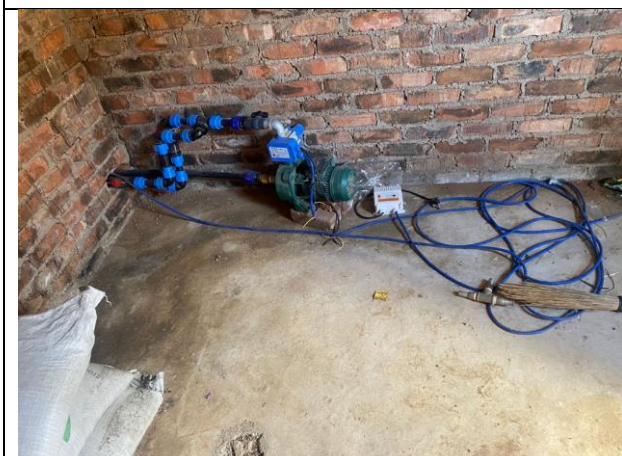
Fig.4.23: Water Infrastructure – water pump

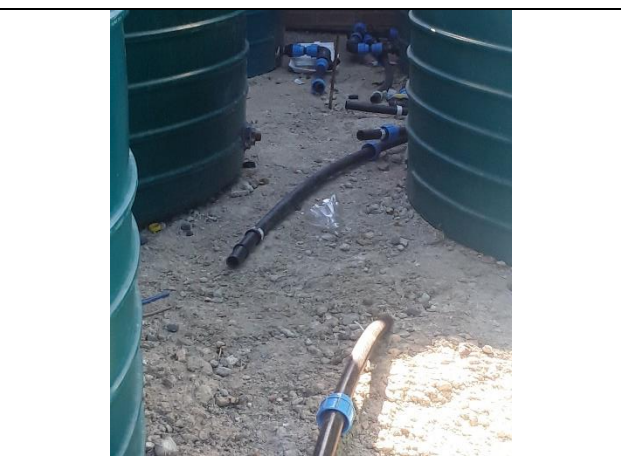
Fig.4.24: Loose pipes/ Incomplete connections needs to tidied and fixed up
